Case 385 : Narrative

Case Vehicle (A): 2000 Chevrolet	Vehicle (B): 1996 Dodge
Type: Tahoe, 4 x 4, 4-door SUV	Type: Stratus, 4-door sedan
Driver: 69-year-old male	Driver: 17-year-old male
CDC: 01-FDEW-2	CDC: 10-LYAW-3

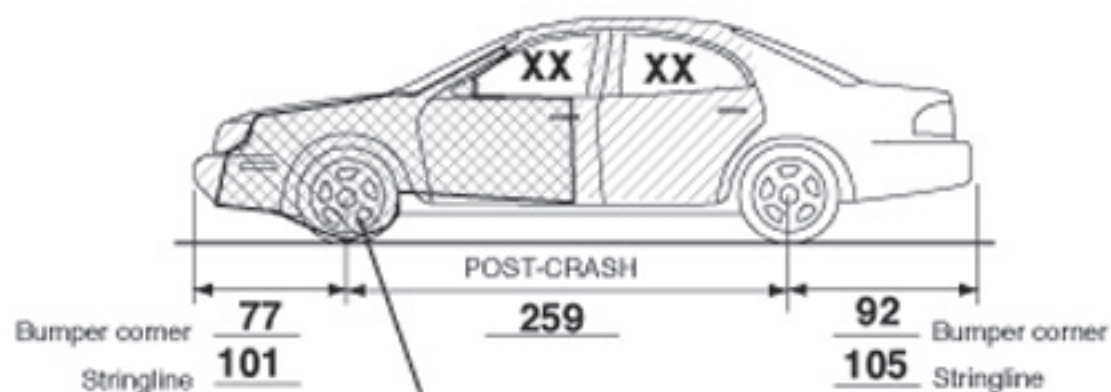
Left-front wheel partially torn off, rim damaged and tire flat

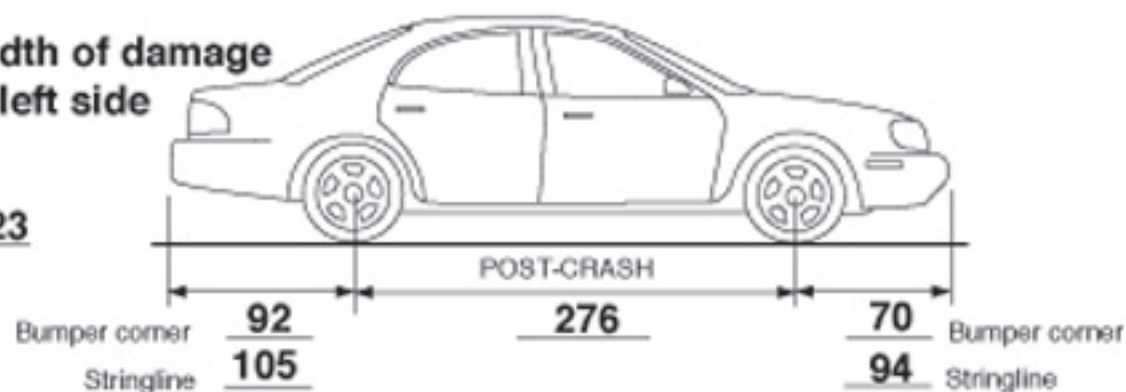
Max. crush to left side at the center of the driver door
